REPORT: Cubic Zirconia Plate Cutting by Laser-MicroJet® – Speed Improvements

for Anonymous

<div>SYNOVA Ch. Dent-d'Oche CH-1024 Ecublens Switzerland www.synova.ch</div>	APPLICATION REPORT	Report No: 122-1
		Sample No: 2.2.1051
		CONFIDENTIAL

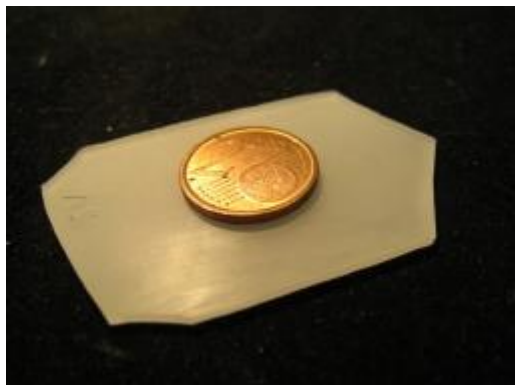
FIGURE 1: Cubic zirconia plate to be cut into small cubes.

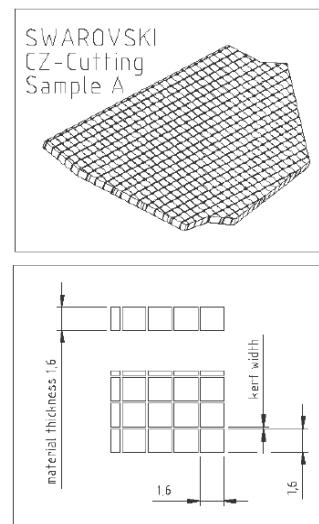
FIGURE 2: Layout of the cuts to get small cubes of 1.6 x 1.6mm.

First, lines were cut into the plate in one direction. The process was optimized using the “first cuts” parameters from above. This way, a comb-like structure was obtained (bars fixed at one end). The bars were then cut into cubes using the “cross cuts” parameters. These parameters were slightly different because the waterjet is disturbed at the line intersections. The efficiency is slightly lower and the lines are not completely cut through (see Figure 5 below). To obtain the final cubes, the remaining material is broken.

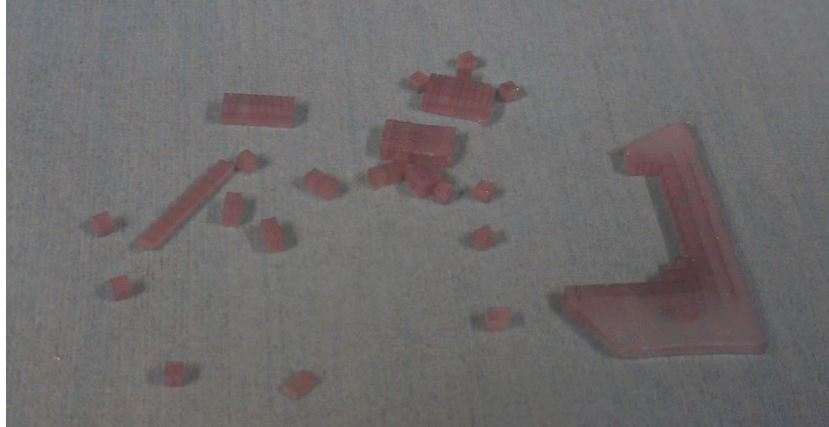
FIGURE 3: Cubic zirconia plate after cutting bars and cubes.

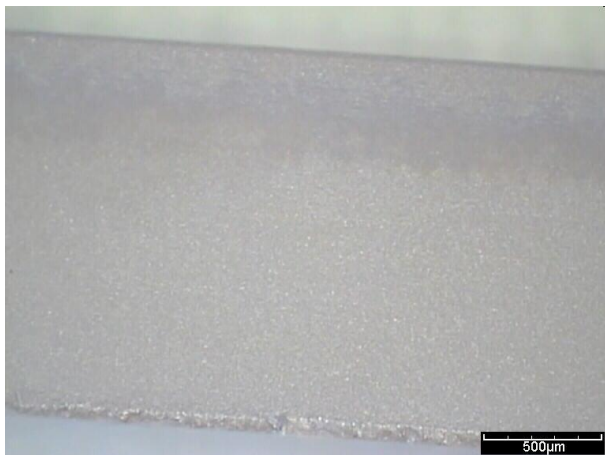
FIGURE 4: Side view of a cubic zirconia bar after the cut in the first direction.

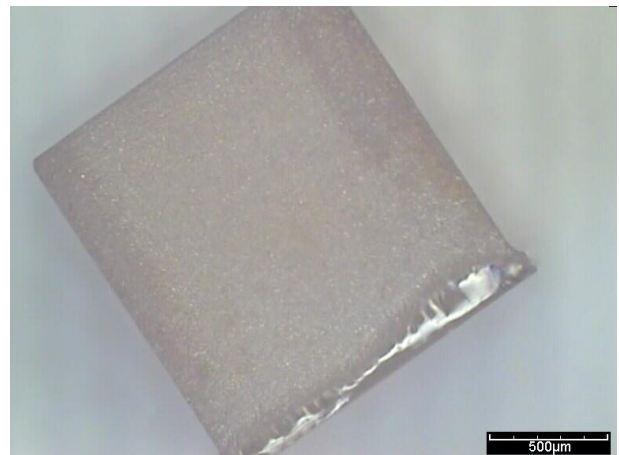
FIGURE 5: Side view of a cubic zirconia cube after the cut in the "cross" direction. Around 15% of the total thickness is not cut through. The cube has been separated from the rest of the bar by breaking this remaining part.
