<b>SYNOVA</b> Ch. Dent-d'Oche CH-1024 Ecublens Switzerland www.synova.ch	<h1 style="text-align: center;">APPLICATION REPORT</h1>	Report No: 139-3 Sample No: 2.2.1304
		<b>CONFIDENTIAL</b>

## REPORT: **Carbon-fiber-reinforced-polymer cutting by Laser MicroJet®**

### TASK

The Laser MicroJet® technology has been tested for cutting carbon-fiber-reinforced polymer. Several plates were provided for the trials, which were performed in your presence.

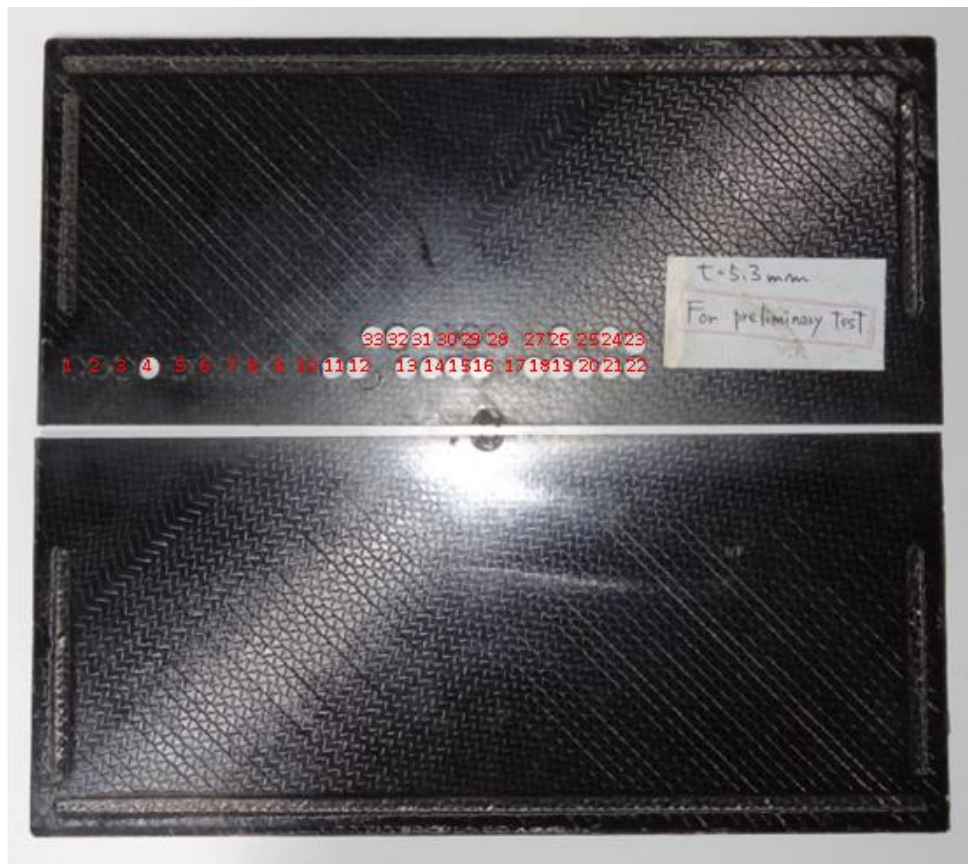
At total of 33 holes were drilled in half of the plate for the preliminary tests, as seen in the picture below, where all holes are identified by a number. Although most of the holes are considered through, we should notice that nearly all the drilled cylinders had to be removed from the plate by pushing them. There were indeed generally some little bridges left.

**PICTURE 1:** Overall view of the processed sample.

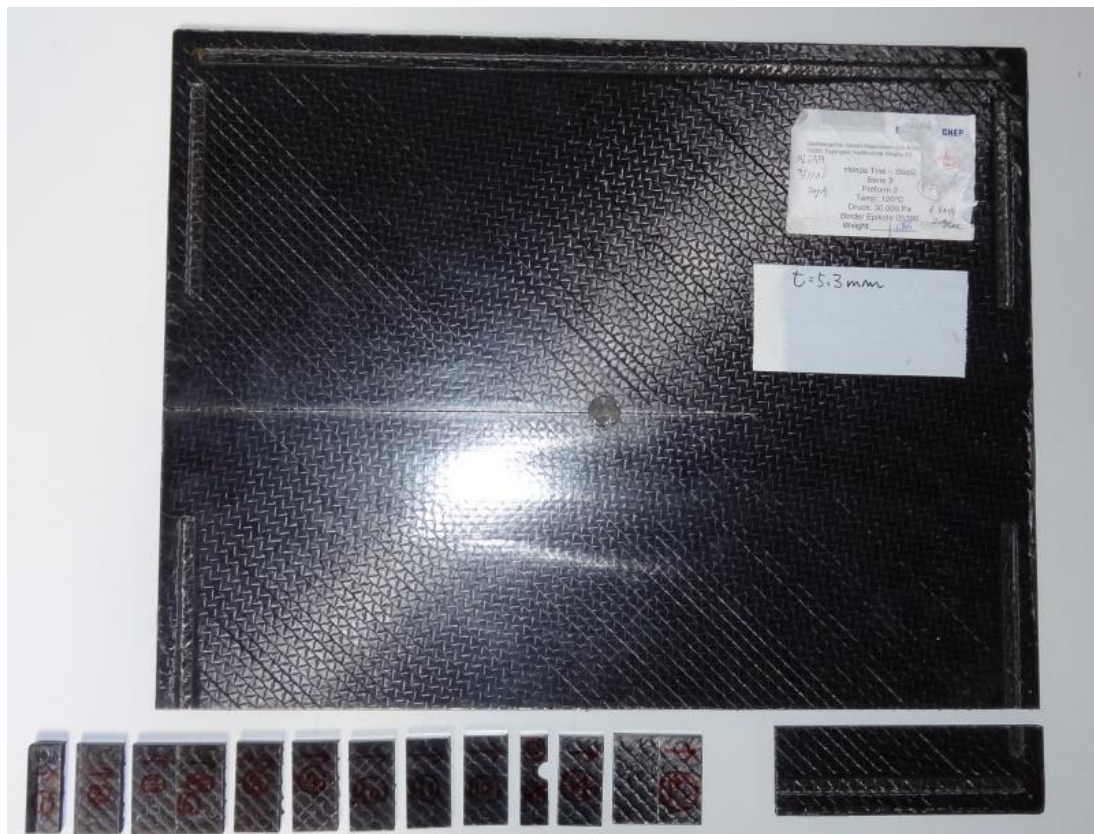
In this sample, we mainly processed slices in a 40mm-wide band, as shown below. Two circles were also drilled, and cross-sections of these parts were made. All parts were identified by a number given by you during the visit. These numbers are written on the parts.

**PICTURE 2:** Overall view of the processed parts.

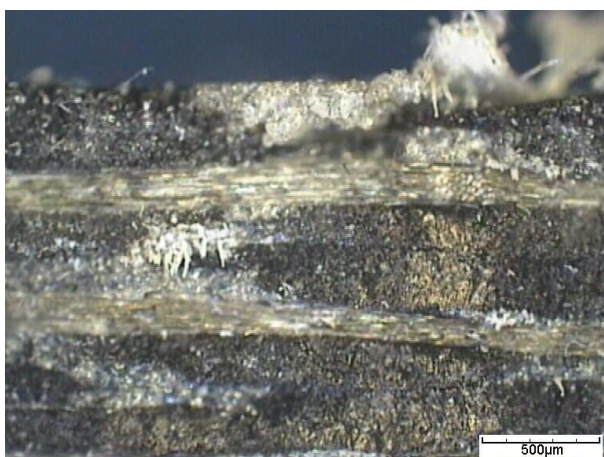
**PICTURE 3C:** Image of the top of the cut wall of part 11, where the sewing thread was cut.

Bridges appeared preferentially below the positions where sewing threads on the top surface were cut (pictures 3C and 3D). This may be due not to the thread itself, but rather to the higher thickness of pure epoxy resin at the top surface. While carbon is easy to cut, this resin seems to be hard to process with our technology. However, we noticed that smaller motion speeds could allow to minimize the size of bridges (picture 4).

The following pictures show the typical quality that was obtained in these experiments. While the cut wall is rather smooth on most of the surface (pictures 3A and 3B), there are often bridges below cut sewing threads (pictures 3C and 3D).

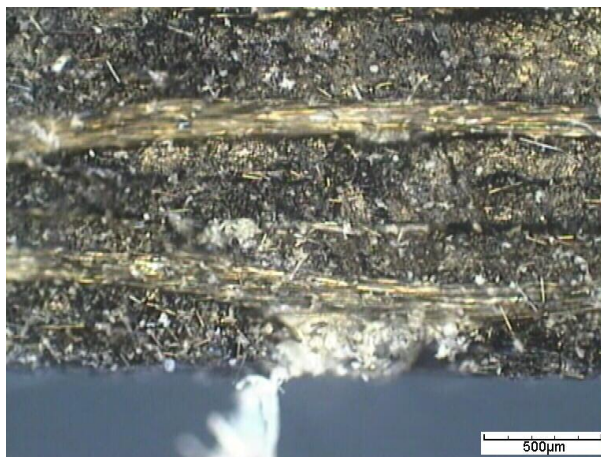
**PICTURE 4:** Image of the bottom of the cut wall of part 12, below a cut sewing thread, showing a very small bridge.

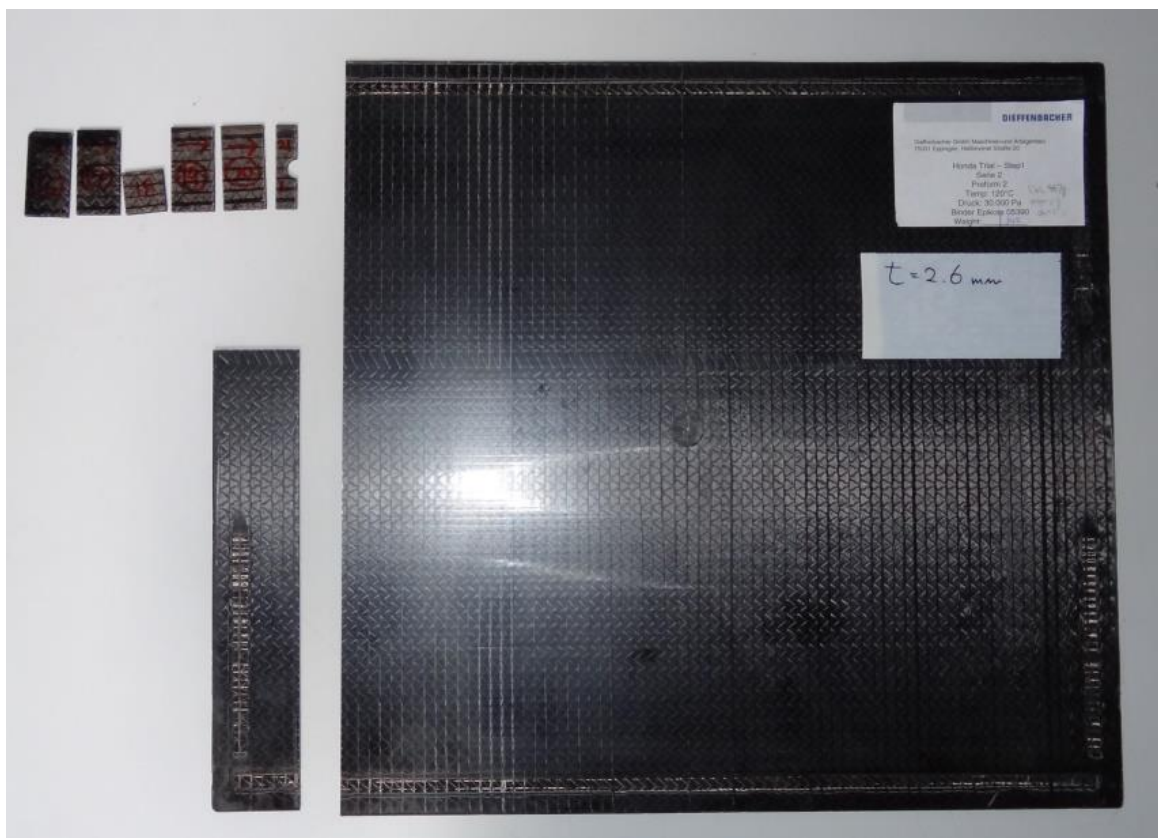
In this sample, we mainly processed again slices in a 40mm-wide band, as shown below. Two circles were again drilled, and cross-sections of these parts were made. As before, all parts were identified by a number given by you during the visit, and these numbers are written on the parts.

A difference, however, is that we grooved three lines on part 18, using different number of passes. We then made a cross-section of them in order to observe the profile.

**PICTURE 5:** Overall view of the processed parts.

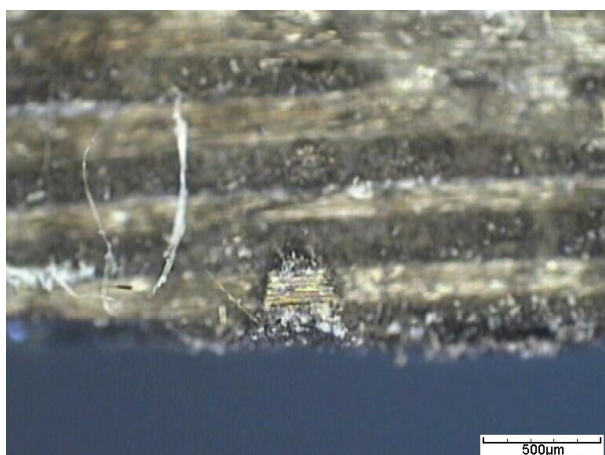
**PICTURE 6C:** Image of the top of the cut wall of part 18, showing a very small bridge.

The following pictures show that quality is similar to the previous sample. There are still some bridges, but they are much smaller than previously (picture 5C).

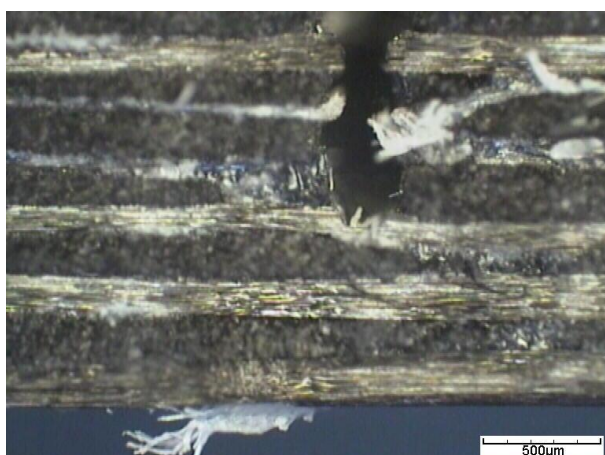
**PICTURE 6E:** Cross-section of the line grooved with 10 passes.

Pictures 5D, 5E and 5F present the profiles of the grooved lines, respectively with 5, 10 and 15 passes. For reference, the cut begins to be partially through after 20 passes, and 25 passes were used in order to minimize bridges.

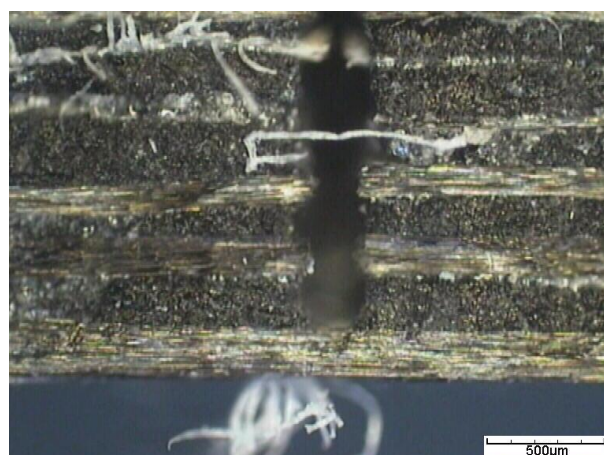
**PICTURE 6F:** Cross-section of the line grooved with 15 passes, close to the bottom.
