REPORT: Cutting of Carbon Fiber Reinforced Polymere by Laser-MicroJet®

For Anonymous

by Mr. Stéphane Delahaye; Synova SA

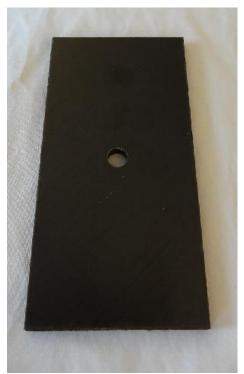
PICTURE 1: Digital camera picture of the sample

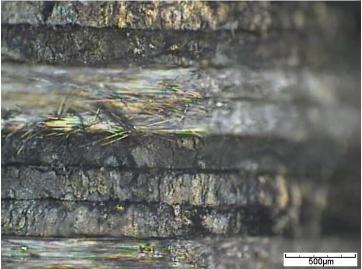
PICTURE 7: Microscope image of the sidewall (dark field illumination)

SAMPLE 2 CFK
